**Flood Control Project Maintenance
Levee Inspections****LMA District Cover Sheet****Spring 2015 Levee Inspection Results****Reclamation District No. 2068 Yolano**

Spring 2015 Levee Inspection Results

Reclamation District No. 2068 Yolo

Waterway			Bank	Unit Miles
Unit No. 01 Yolo Bypass			Right	5.48
	Spring (March - May)	Summer (June - August)	(September - November) Fall	Winter (December - February)
Unit Maintenance Rating (Fall Only)				
Date of Inspection	05/14/2015 - 05/14/2015			
DWR Inspector	Herman Phillips			
Accompanied By

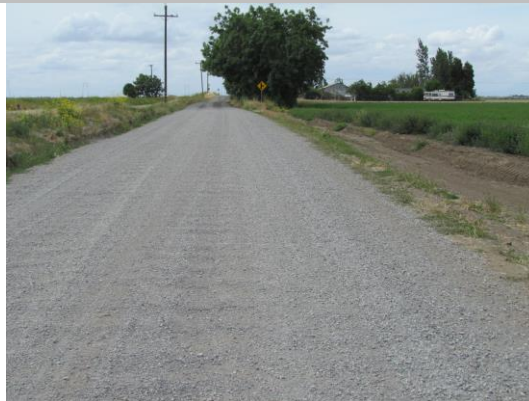
Photo 1 of 1 : SP_2015_RD2068_193_16_20150604_00001.jpg

LM Start	0.00	Rating **	A	Issue No.	16
LM End	0.00	Issue Type +	Ma	Location *	LS
Category	Earthen Levee			GPS Latitude/Longitude	
				Start	End
Item	Vegetation			38.402836 °	38.402836 °
				-121.693780 °	-121.693780 °
DWR ID	DWR_RD2068_01_s _ 2015_16				
Action/Comments					
Control annual grass and weeds on the levee slopes and easements.

View looking downstream at the landside slope.

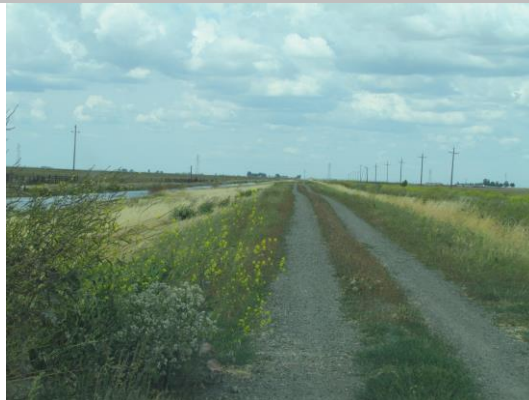
Photo 1 of 1 : SP_2015_RD2068_194_9_20150604_00004.jpg

LM Start	0.05	Rating **	M	Issue No.	9
LM End	0.46	Issue Type +	Ma	Location *	LS
Category	Earthen Levee			GPS Latitude/Longitude	
				Start	End
Item	Vegetation			38.358823 °	38.364873 °
				-121.740405 °	-121.740298 °
DWR ID	DWR_RD2068_02_s_2015_9				
Action/Comments					
Control annual grass and weeds on the levee slopes and easements.

View looking downstream at the levee section.
